Corrosion Under Insulation Technologies – High performance solutions

ABSTRACT

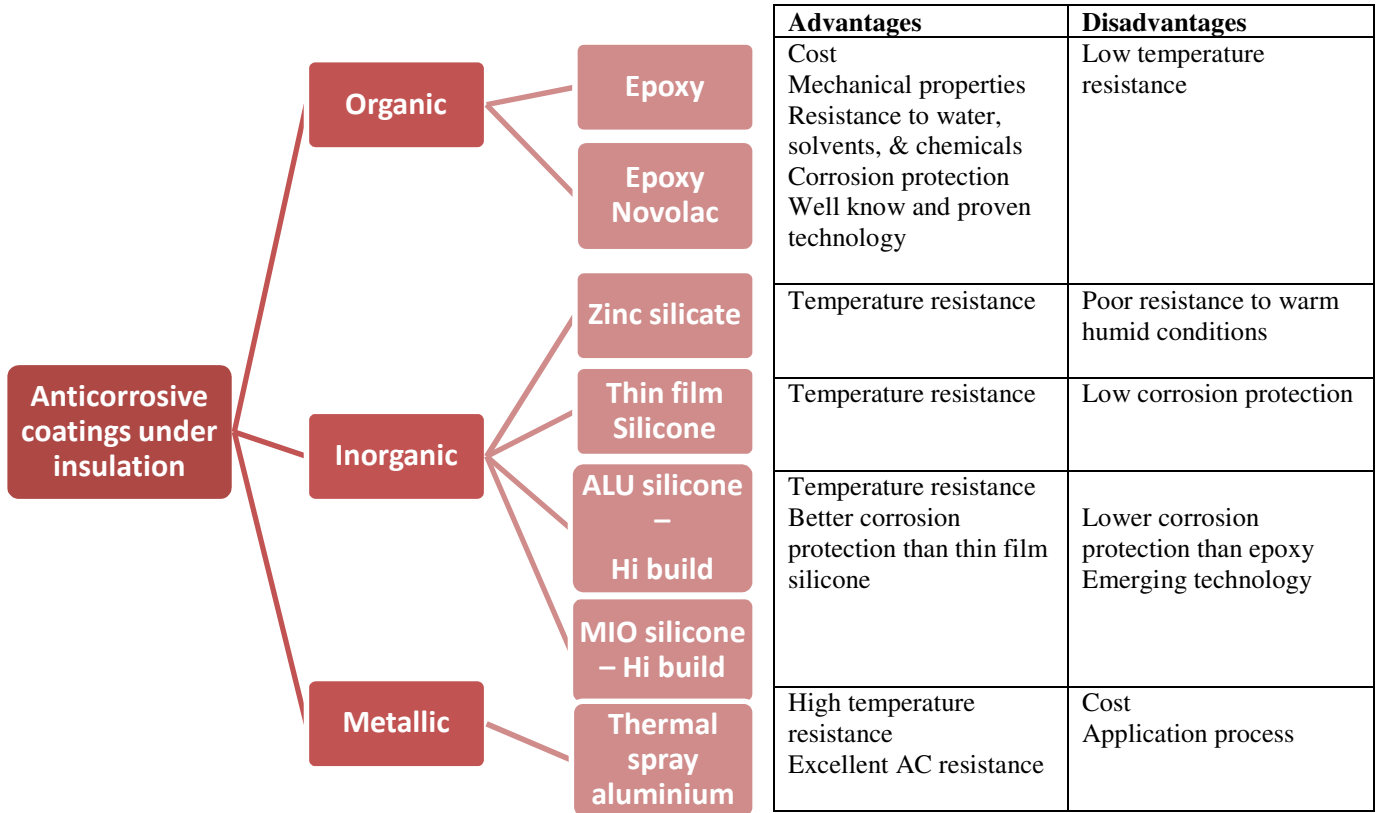
Figure 2: Examples of three groups of coatings to be used under insulation: organic, inorganic and metallic.

Figure 2 gives a short summary of coating types currently and historically used under insulation. The first group consists of the organic types (epoxy, phenolic epoxy and novolac epoxy). They give excellent protection against water and salts etc., however the disadvantage is that they degrade at moderate temperatures and cannot be used for the hottest areas. Among the second group, the inorganic types, we find the zinc silicates. They resist higher temperature than the organic coatings and can provide excellent corrosion protection. Historically these products have been used on insulated pipes with some success. However their use has also resulted in premature breakdown because they are not suitable for a wet and hot environment. At temperatures above 60 °C the dissolution rate of zinc and zinc oxide becomes very

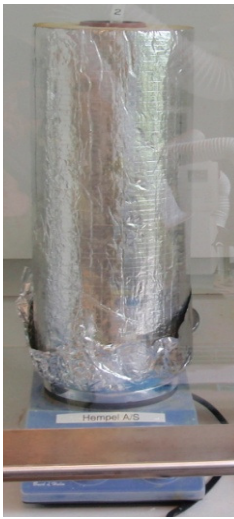
Figure 3: The modified Houston pipe test

- 6) Modified Houston pipe test which consisted of exposing pieces of coated and insulated pipe to cyclic immersion and dry out conditions at elevated temperature, see Figure 3. Two 2 mm wide scribes were made through the coating along the length of the pipes. The exposure cycle consisted of heating on a hot plate for 8 hours (standing in vertical position), followed by cooling down to below 50 °C before a salt solution was poured slowly into the insulation. Then the pipe was placed horizontally (to make sure that the water concentration was the same throughout the pipe length) for another 14 hours and finally set back on the hot plate. The procedure was repeated 21 times for a total of 3 weeks of exposure. The pipes are evaluated after the test since the insulation has to be removed. The advantage of this setup is that a coating can be tested at wide temperature range in one exposure. A number of thermocouples were inserted into the insulation to measure the steel temperature along the pipe. This is used to make a correlation between temperature and location on the pipe. See Figure 4.

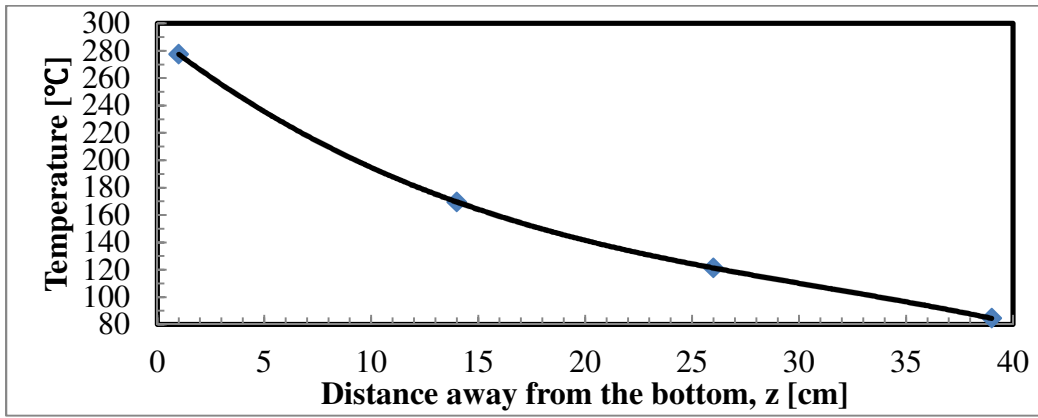
Figure 4: The temperature along the length of the pipe at steady state during the Houston pipe test. The temperature at the bottom of the pipe in direct contact with the hot plate is approx. 290C ($z=0\text{cm}$) dropping to approx. 80 at the top

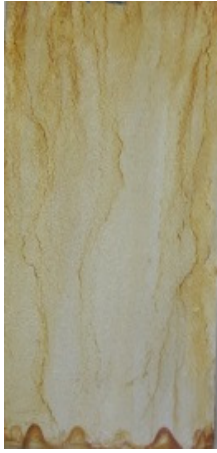
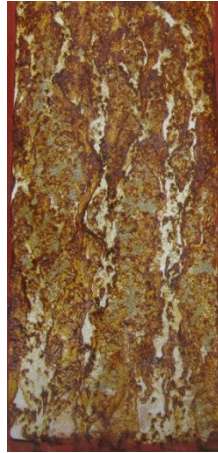
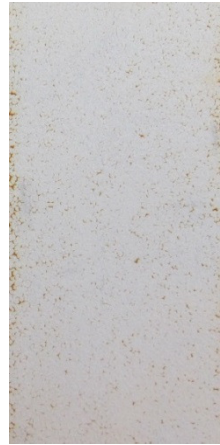
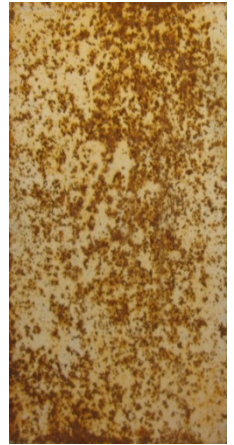
Figure 5: Test of corrosion protection offered by a conventional Thin Film Silicone specification 3 x 25 μm . The heating to 650 °C caused widespread micro cracking with subsequent corrosion in the salt spray exposure.

Traditional thin film silicones are generally not considered as suitable for CUI protection due to limited corrosion protection and this is confirmed by the results from salt spray testing and cyclic CUI exposure shown in Figure 5. Even short term exposure to salt spray or the cyclic CUI test leads to general breakdown of the system and corrosion. This can be explained by the inadequate barrier properties offered by the rather low film thickness that can be obtained even with a 3 layer specification. More

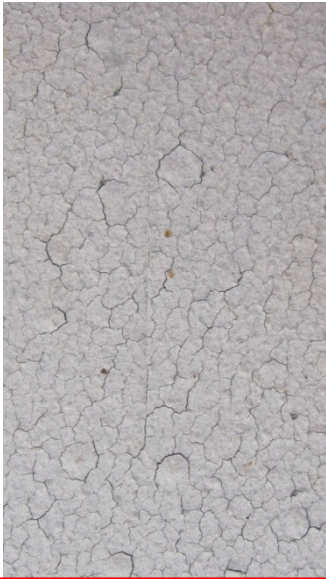
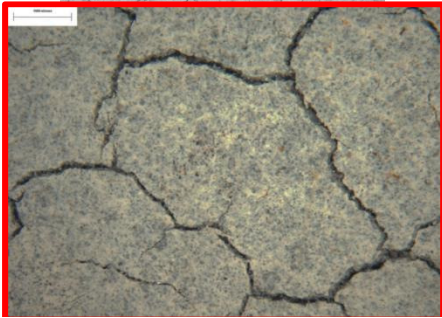
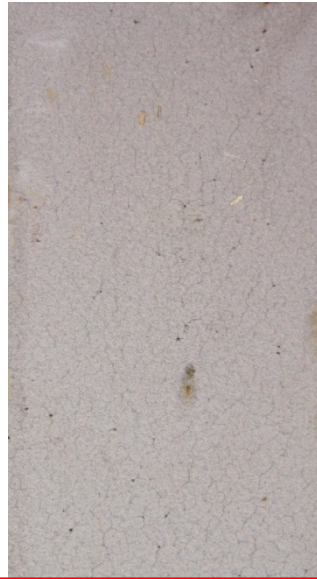
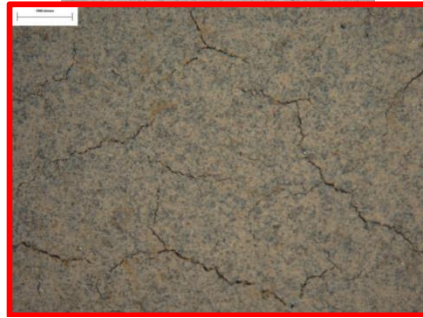
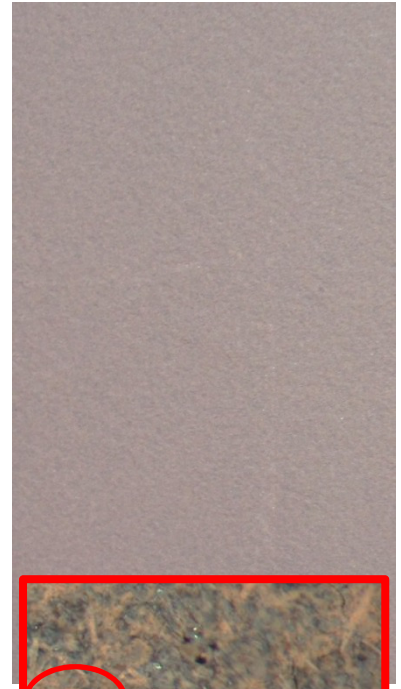
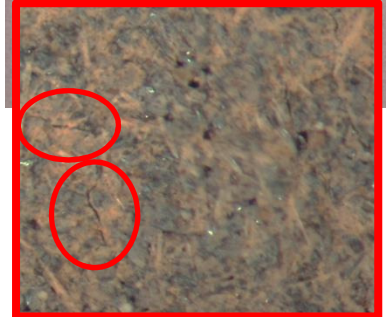
High Build Silicone 1
First sign of cracking 300°C

High Build Silicone 2
First sign of cracking 400°C

Experimental High Build Silicone
First sign of cracking 650°C

Figure 6: Cracks formed after heating 3 high build silicones (1 x 150 μm) to 650 °C.

A number of experimental high build formulations were formulated and screened to identify the best by exposure to dry heat in oven. The two commercial High Build Silicone 1 and 2 were used as references. Several of the experimental formulations cracked at moderate temperatures (300 - 500°C) while a few showed no crack up to 600 °C and only minor cracks at 650°C. See Figure 6. This is better than the two commercial high build silicone products. High Build Silicone 1 cracked already at 300 °C and Build Silicone 2 cracked at 400 °C.

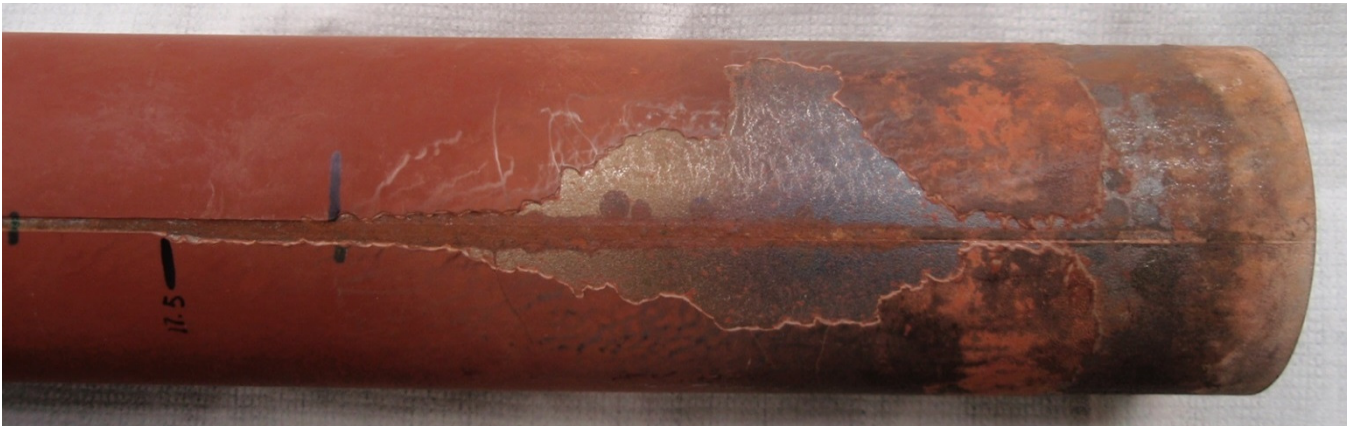
Figure 14: A pipe with 3x100 μm Epoxy Mastic after exposure in the modified Houston piep test. The delamination from the scribe was determined with the tip of a knife to extend to approx. 17.5 cm from the end of the pipe corresponding to a temperature of 153 $^{\circ}\text{C}$.

These findings were supplemented by the modified Houston pipe test. Failure is cracking and delamination (most severe at the bottom of the pipe where the temperature has been highest). Figure 13 and Figure 14 show examples of the Novolac Epoxy and the Epoxy Mastic after exposure.

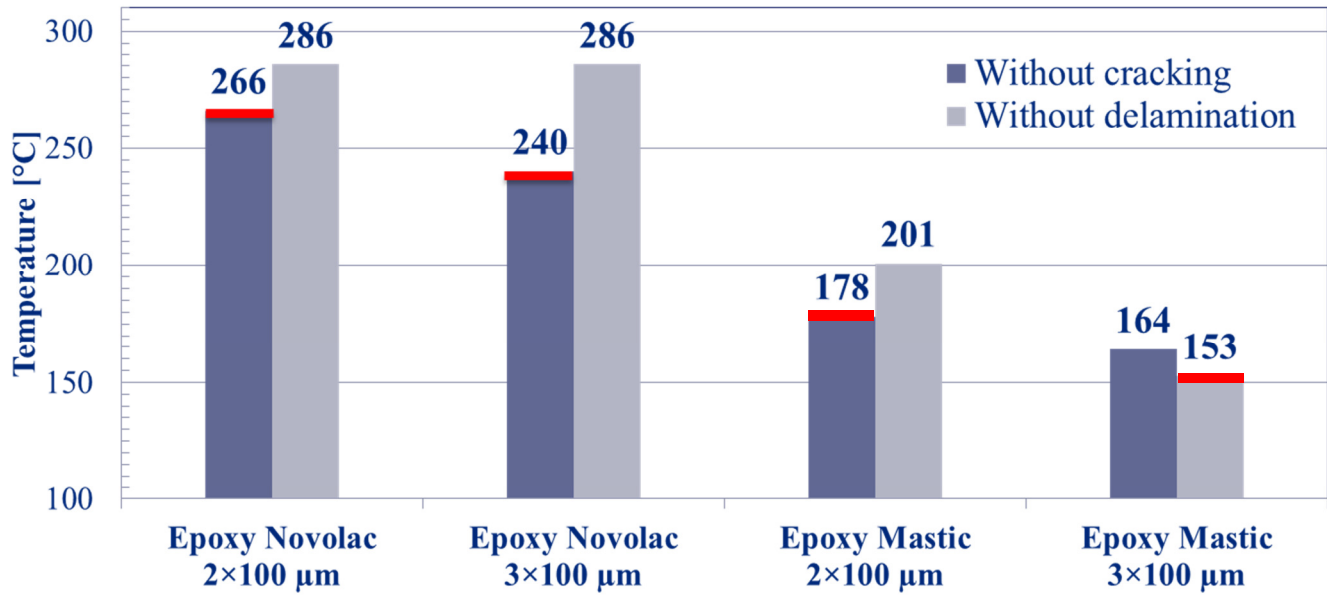
Figure 15: It is clear that the novolac epoxy can reach a higher temperature before cracking and delamination is observed compared to epoxy mastic. The plot here also indicates that a high film thickness is not an advantage.

With the correlation between pipe length and temperature it was possible to identify the temperature at which failure (delamination and cracking) sets in – see Figure 15. It is clear that the novolac epoxy can reach a higher temperature before cracking and delamination is observed, compared to the epoxy mastic. The results also indicate that a high film thickness is not an advantage. Films with 2x100µm resist slightly higher temperature than films with 3x100µm.
